NAME OF PATIENT: Maria Gonzalez (name changed / actual patient report)
DATE OF REPORT: 5/10/2011
DATE OF EXAMINATION: 5/2/2011
REFERRING PHYSICIAN: Dr. Daniel J. Richter
TESTING FACILITY: Brooklyn Accident & Injury Center
INDICATIONS: Whiplash Injury

Digital Motion X-ray Cervical Spine

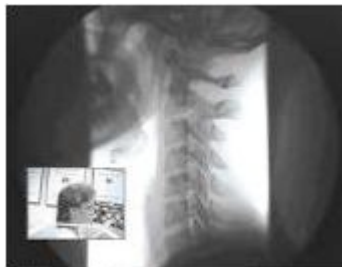
Neutral lateral projection

The integrity of the cervical lordosis and overall condition of the cervical spine is evaluated. The loss of the cervical lordosis may be a result of damage to the posterior longitudinal, capsular or interspinous ligaments.

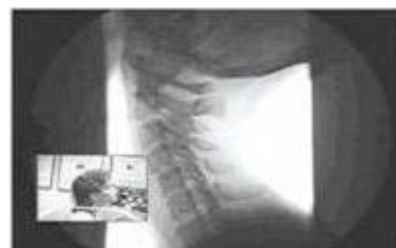
Lateral nodding projection

This view examines the integrity of the transverse ligament which is responsible for preventing the anterior movement of C1 on C2. An increase of the Atlanto-Dens interspace (ADI) indicates damage to the transverse ligament.

Increased ADI space

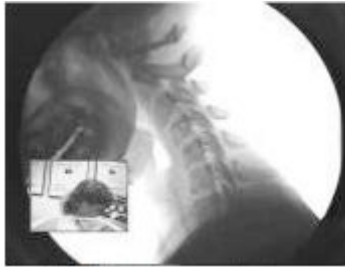
Full flexion projection

This view examines the integrity of the posterior longitudinal ligament demonstrated by a forward (anterior) movement of one vertebrae over the vertebrae below or by the posterior widening of the intervertebral disc space (increased disc angle).

Widening of posterior disc space

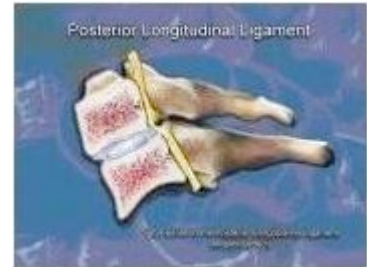
Anterolisthesis

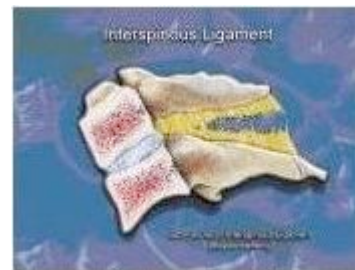
The integrity of the interspinous ligament is evaluated in the lateral flexion view. Damage to this ligament results in increased separation of the spinous processes in flexion.

Damaged Interspinous Ligament

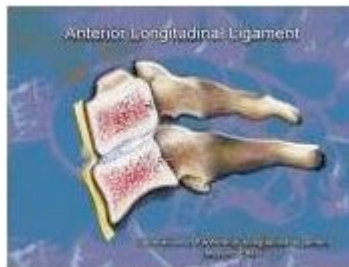
This view examines the integrity of the anterior longitudinal ligament demonstrated by a backward (posterior) movement of one vertebrae over the vertebrae below or by the anterior widening of the intervertebral disc space (increased disc angle).

Retrolisthesis

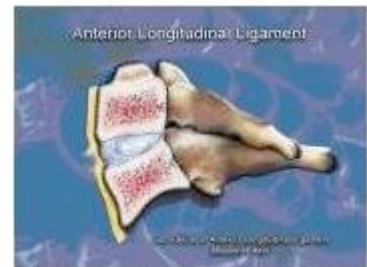
Widening of the anterior disc

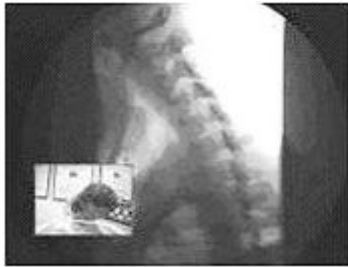
Right IVF flexion

This view examines the integrity of the capsular ligaments by observing gapping of the facet joints, located on the posterior cervical spine (C2-C7), there are five capsular ligaments on the right and the left.

Capsular ligament damage

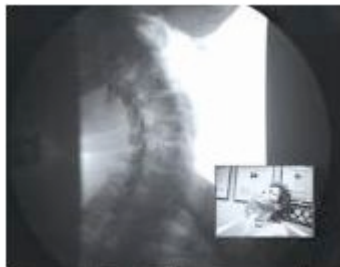
Left IVF oblique extension

This view examines the integrity of the capsular ligament by encroachment into the intervertebral foramen, located on the posterior cervical spine (C2-C7), there are five capsular ligaments on the right and the left.

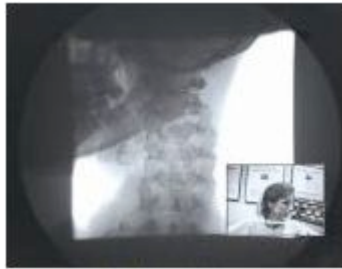
Left rotation

This view examines the rotational range of motion between Occiput-C1-C2. Increased motion indicates damage to the alar and accessory ligaments.

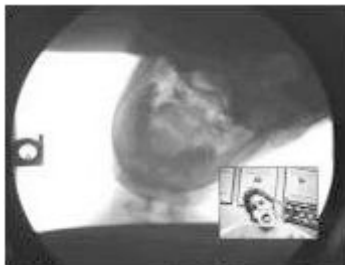
Open mouth right lateral bending

This view examines the integrity of the alar and accessory ligaments either by the lateral overhang of C1 on C2 or by the changes in the para-odontoid spaces.

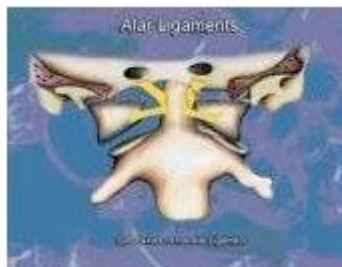
C1 lateral mass overhang

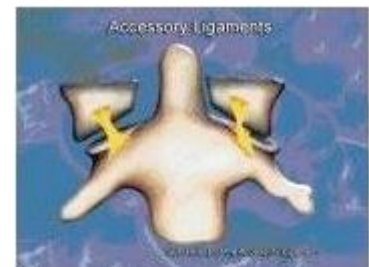
Change in Para-odontoid space
